Idaho State Department of Agriculture  
Division of Agricultural Resources

**Dennett Creek  
Water Quality Monitoring Report**  
April 2003 through October 2003

ISDA Technical Report Summary W-10

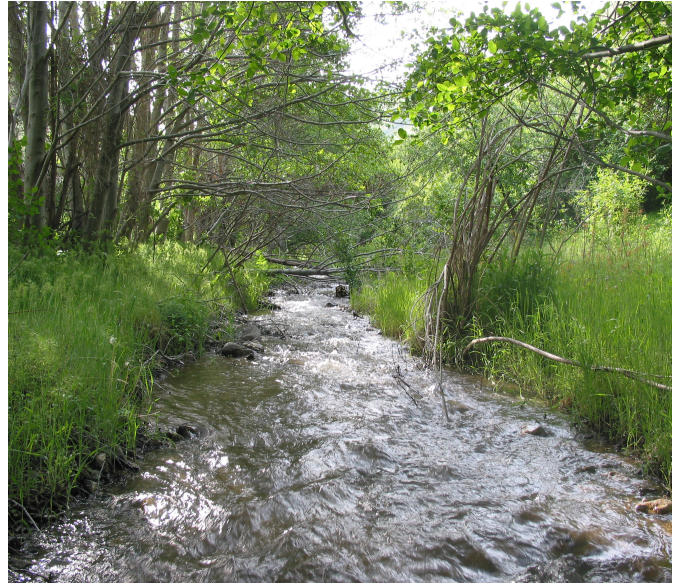
The photographs on this page only represent a small area of Dennett Creek. From our sampling point (Photo 1) the upstream sites (Photo 2 & 3) only encompass approximately 1.5 miles. Dennett Creek is approximately 6.5 miles long and the creek's condition in the upper reaches were not visually evaluated during this program. Photograph 1 is our sampling location and is just above where Dennett Creek drops down through a culvert into a gravel washout area prior to reaching Brownlee Reservoir (Photo 4).

The riparian area that was viewed (Primarily photo's 1, 2, and 3) appeared to be relatively healthy with good vegetation and plenty of woody debris within channel. There was very little sign of cattle activity in and along the banks and only a few cattle were observed within the area during our visits. There were some cut banks further up on Dennett Creek but the area still appeared to be well vegetated with the stream still having good access to the flood plain.

Photo # 1. ISDA sampling site on lower Dennett Creek (May)

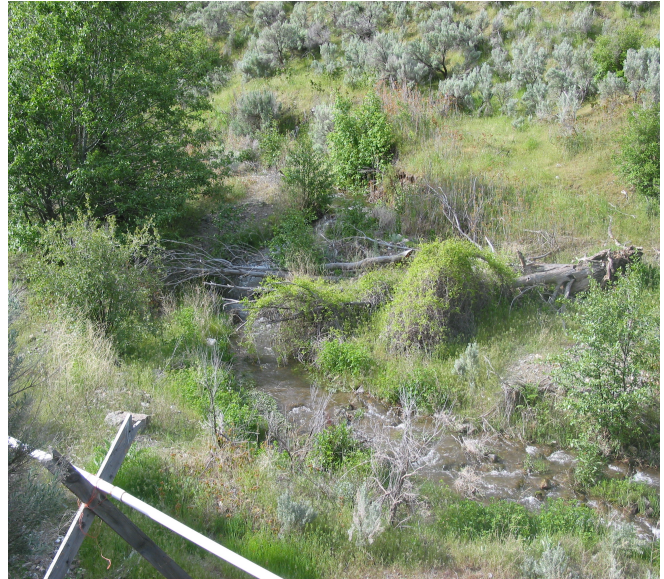
Photo # 2. Dennett Creek upstream of sampling site (May).

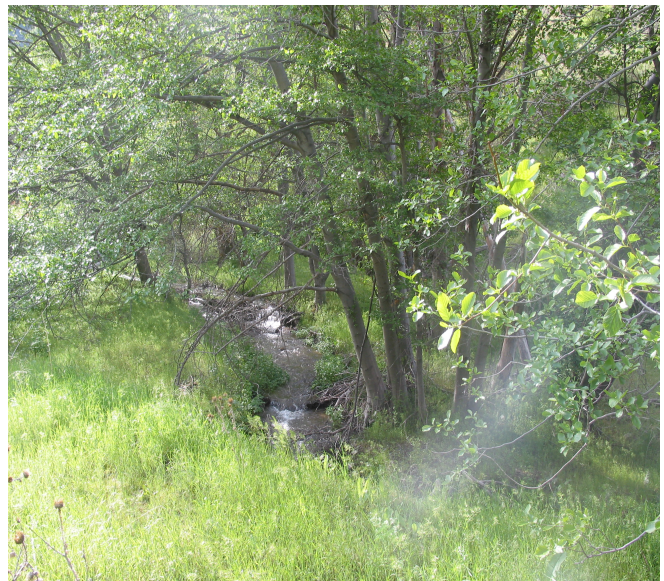
Photo #3. Upstream areas on Dennett Creek (May).

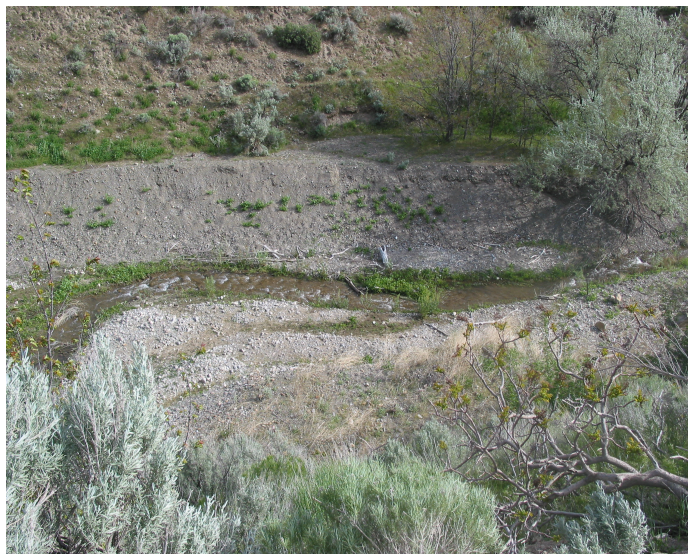
Photo # 4. Lower Dennett entering Brownlee cove (May).

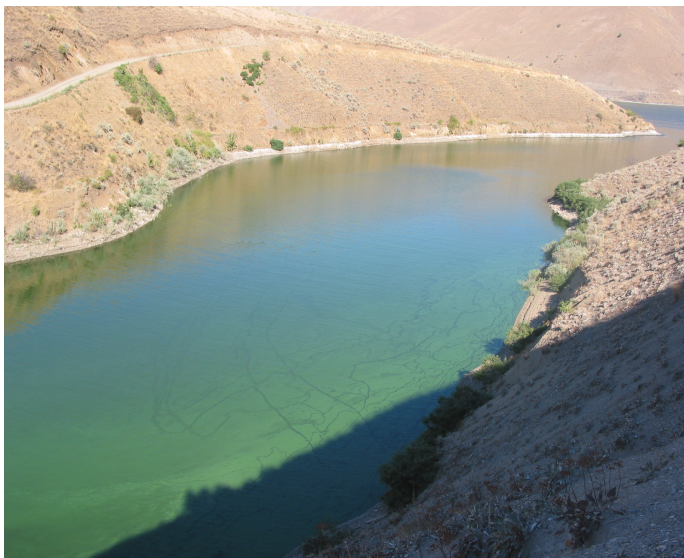
Photo #5. Arm of Brownlee Reservoir in August exhibiting large algae blooms (late September).

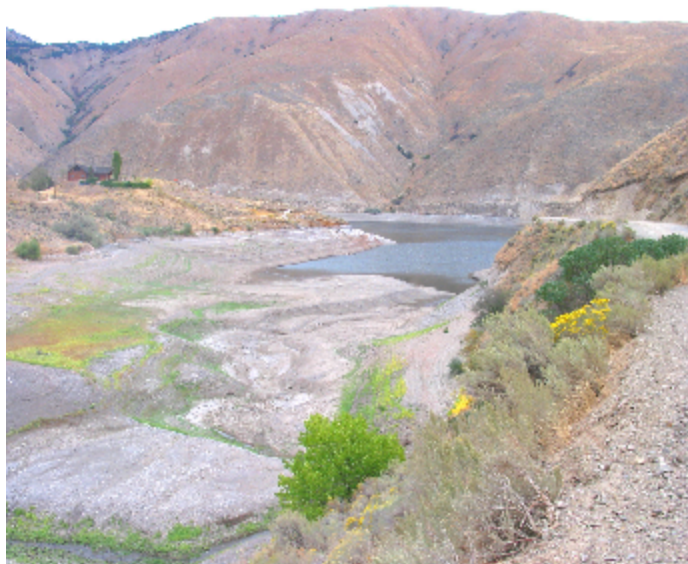
By mid September and into October Brownlee Reservoir's water level has been severely drawn down. Dennett Creek no longer reaches Brownlee Reservoir by October (Photo 6).

Photo #6. Dennett in October no connectivity to Brownlee
